Inspection Report

**Happy Homebuyer
123 Rainbow Rd.
Friendlytown, MA 01234**

Inspection Location: **123 Rainbow Rd.**

Date: **July 4th, 2018**

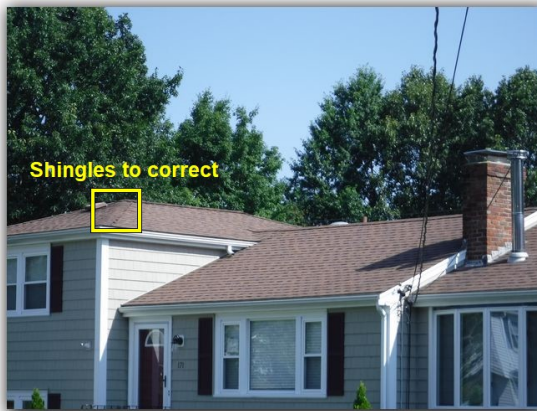
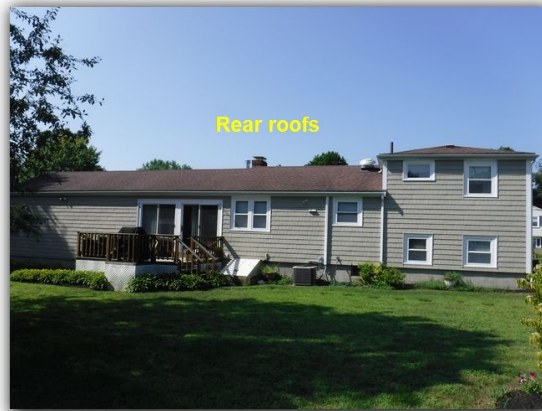
1	Roof coverings:	Defective	Recommend roofer for correction of shingles showing excess deterioration (see picture for example).	
2	Ventilation:	Acceptable	No Action Required	
3	Flashings:	Acceptable	No Action Required	
4	Skylights:	Not Present	No Action Required	
5	Chimneys:	Acceptable	No Action Required	
6	Drainage/Gutters:	Marginal	Extend downspouts away from house to assist with drainage (ex. front corner).	
7	Water Penetration:	Acceptable	No Action Required	
8	Roof Penetrations:	Acceptable	No Action Required

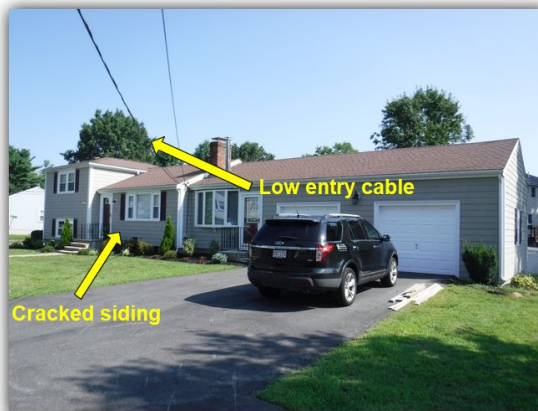
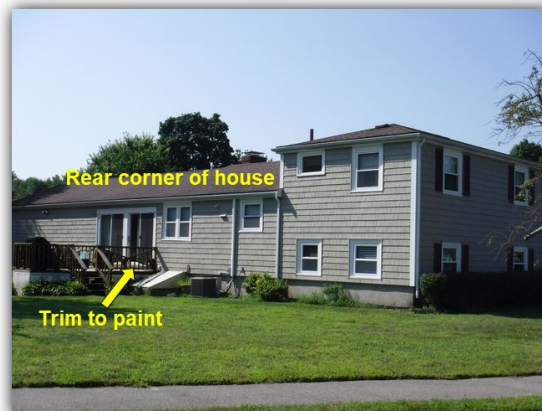
COMPONENT	CONDITION	NOTES / RECOMMENDATIONS	PERSPECTIVE
EXTERIOR			
1 Siding:	Marginal	Correct damage/cracking.	Minor Concern
2 Trim/fascias/soffit:	Marginal	Scrape and paint wood trim (under rear slider)	Maintenance Item
3 Veneer:	Acceptable	No Action Required	
4 Doors:	Marginal	Bulkhead entrance does not have a weather sealed door.	
5 Windows:	Acceptable	No Action Required	
6 Faucet/fixtures ¹ :	Acceptable	No Action Required	
7 Electrical cable:	Marginal	Consult electrician for service entry cable that is low over the driveway.	
8 Flashings ² :		Above siding/trim evaluations include their associated flashing.

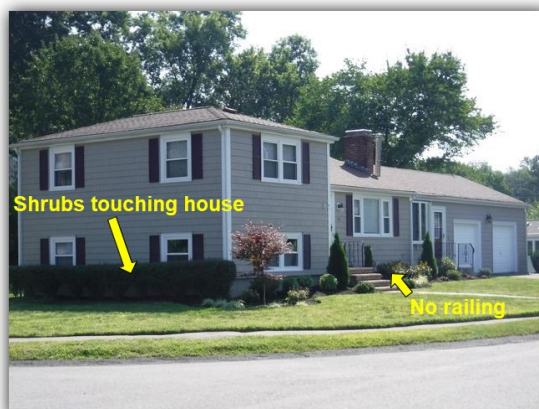
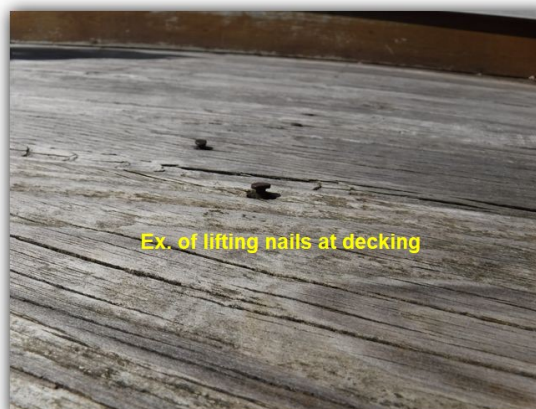
COMPONENT	CONDITION	NOTES / RECOMMENDATIONS	PERSPECTIVE
Grounds and Drainage			
1	Drainage:	Acceptable	No Action Required
2	Vegetation:	Marginal	Trim back or remove side shrubs in contact with house.
3	Steps/Walks:	Marginal	Recommend railing along stairs at front entrance. Safety Hazard
4	Decks/Porches:	Marginal	Decking is due for maintenance and nails are lifting.
5	Driveway:	Acceptable	No Action Required
6	Retaining Walls:	Not Present	No Action Required
7	Patio:	Acceptable	No Action Required
8	Grading:	Marginal	Recommend installing window wells for basement window that are at or below grade (ex. front of house).

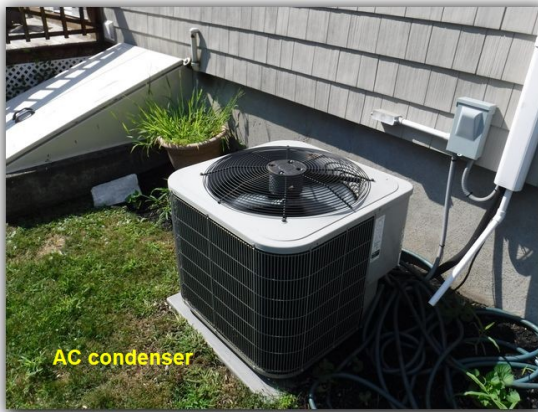
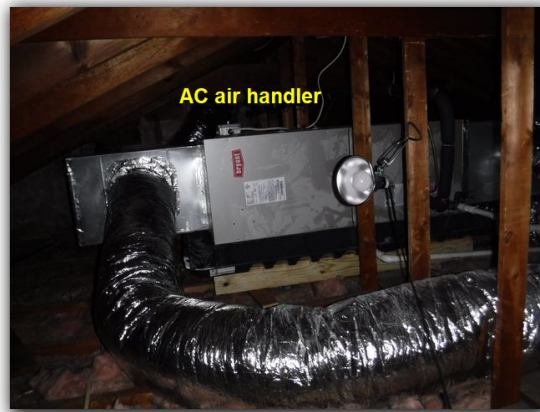
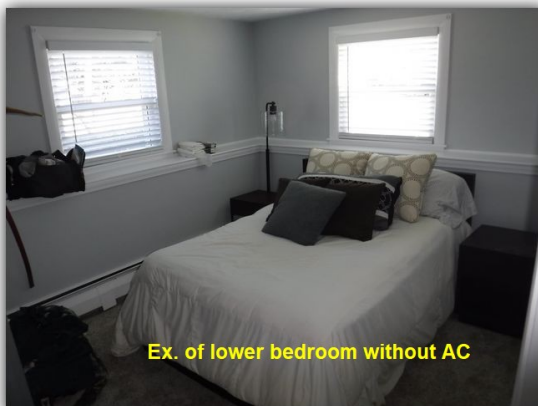
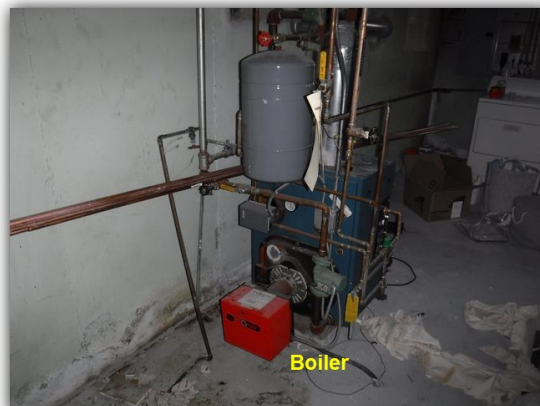
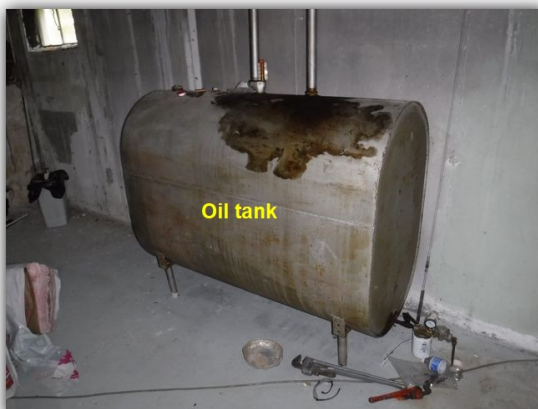
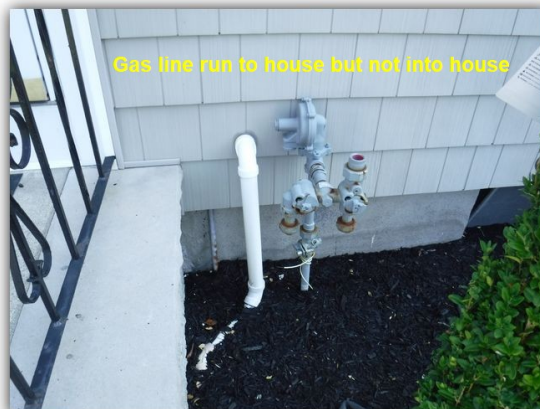
COMPONENT	CONDITION	NOTES / RECOMMENDATIONS	PERSPECTIVE
Heating and Cooling			
1 A/C system/func:	Acceptable	Temp coming out of vents is at 45 degrees at time of inspection.	
2 Heat system/function 1:	Marginal	Pressure is reading high and there is no evidence of any recent service. Recommend further evaluation/service by licensed technician.	
3 Exhaust system:	Acceptable	No Action Required	
4 Distribution:	Marginal	There is no AC in lower bedrooms. Add as needed.	
5 Insulation:	Acceptable	No Action Required	
6 Thermostat/controls:	Acceptable	No Action Required	
7 Burner(s):	Acceptable	View of burner is limited, no view of firebox.	
8 Oil Tank(s)+ line:	Marginal	There is corrosion and previous seepage viewed. Have evaluated by professional during service.	
9 Air filter:	Acceptable	No Action Required

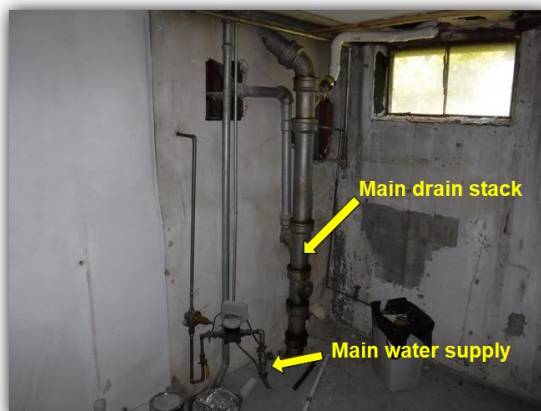
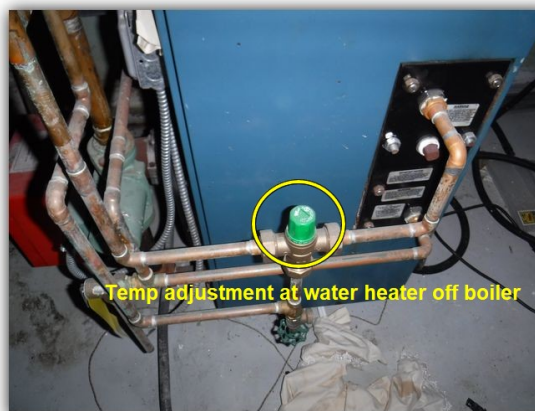
COMPONENT	CONDITION	NOTES / RECOMMENDATIONS	PERSPECTIVE
PLUMBING			
1 Supply pipes:	Acceptable	No Action Required	
2 Waste/Vent pipes:	Marginal	Some corrosion is viewed. Monitor for any seepage/leaking and repair if needed.	
3 Funct'l water flow:	Acceptable	No Action Required	
4 Funct'l waste drain:	Acceptable	No Action Required	
5 Well system:	Not Present	No Action Required	
6 Water Heater 1:	Defective	Water heater is not producing sufficient hot water at time of inspection. Recommend plumber.	
7 TPR Valve:	Acceptable	No Action Required

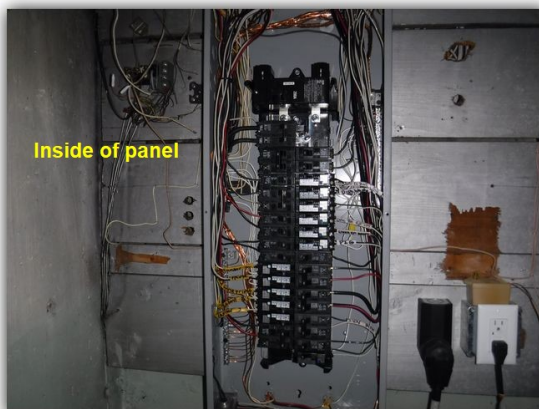
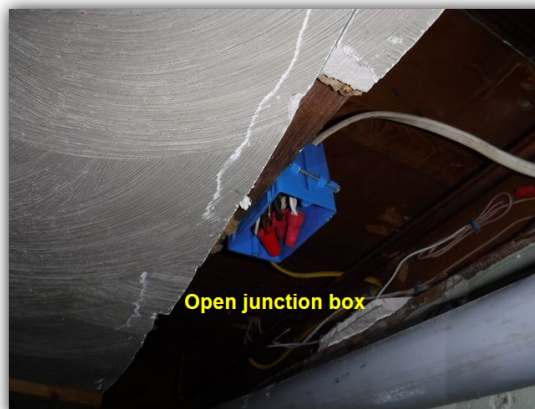
COMPONENT	CONDITION	NOTES / RECOMMENDATIONS	PERSPECTIVE
ELECTRICAL			
1	Panels:	Acceptable	No Action Required
2	Corrosion in panel:	Acceptable	No Action Required
3	Grounding:	Acceptable	No Action Required
4	GFCI ¹ :	Marginal	Add GFCI protection where needed per electrician (ex. fan in upper shower, outlets at exterior, and outlets at garage)
5	Service/Amperage:	Acceptable	No Action Required
6	Wiring:	Marginal	Correct any exposed wire junctions (ex. open junction boxes in basement).
7	Outlets/switches:	Acceptable	No Action Required
8	Fixtures:	Acceptable	No Action Required

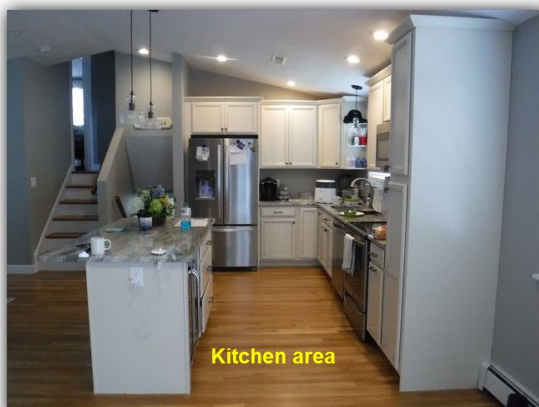
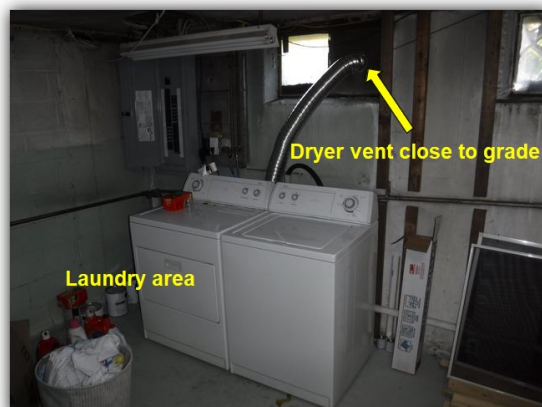
14	Washer plumbing:	Acceptable	No Action Required	
15	Sink :	Not Present	No Action Required	
16	Cabinets/shelves:	Acceptable	No Action Required	
18	:Dryer vent:	Marginal	Keep exit to exterior clear from snow in winter months. Upgrade height as needed.	
19	Dryer service:	Acceptable	No Action Required	
20	Dryer service type	Electric 4 prong		
21	Laundry location ² :	Basement

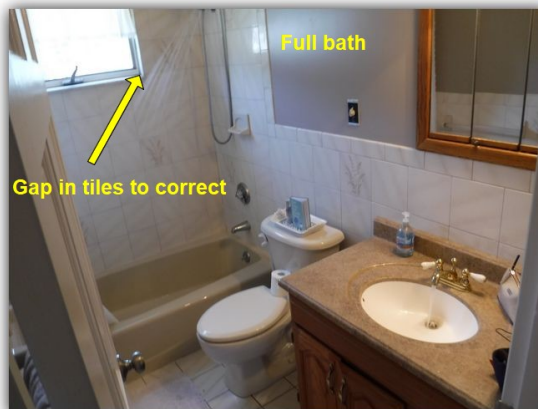
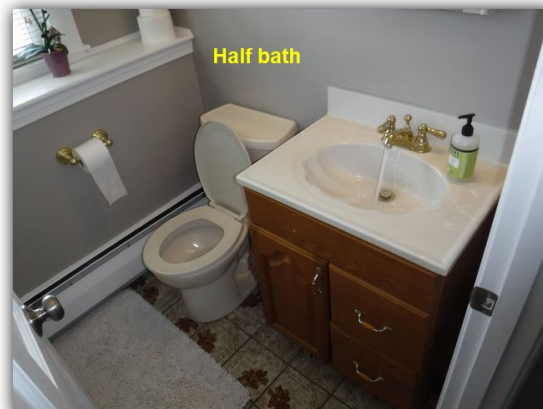
1	Wall,.ceiling, floor:	Acceptable	No Action Required	
2	Doors:	Acceptable	No Action Required	
3	Heating & cooling:		Refer to Heating/Cooling page.	
4	Cabinet & counter:	Acceptable	No Action Required	
5	Vents:	Marginal	Upper bath vent does not show evidence of exhausting to exterior and is not visible in attic. Further investigate and correct if needed. There is no vent in half bath.	
6	Sinks:	Acceptable	No Action Required	
7	Toilets:	Acceptable	No Action Required	
8	Tubs:	Acceptable	No Action Required	
9	Showers	Marginal	Seal any gap in tile to prevent water penetration through wall.	
10	Jet Tub:	Not Present	No Action Required

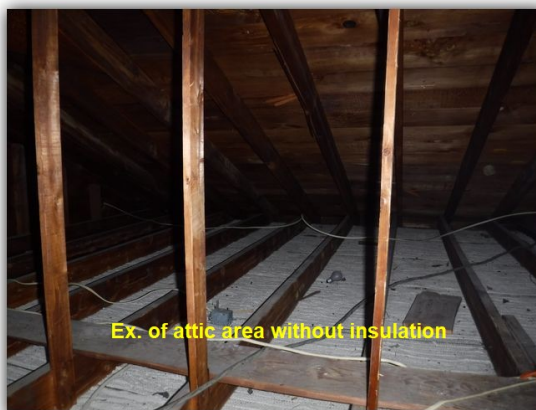
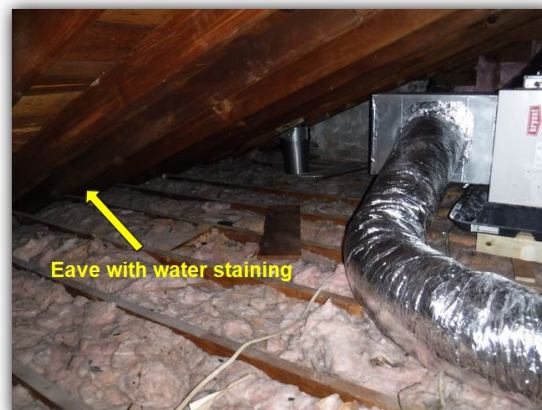
COMPONENT	CONDITION	NOTES / RECOMMENDATIONS	PERSPECTIVE
ATTIC			
1	Access:	Marginal	There is no access to any attic above cathedral ceiling and view of accessible attics is limited to what can be seen from hatch.
2	Framing:	Acceptable	No Action Required
3	Sheathing:	Acceptable	No Action Required
4	Insulation:	Defective	Add were missing (see picture).
5	Ventilation:	Acceptable	No Action Required
6	Plumbing vents:	Acceptable	No Action Required
7	Chimney & flues:	Acceptable	No Action Required
8	Water Penetration	Marginal	There is evidence of previous water with staining at eaves (dry at time of inspection). Follow up for history, monitor closely, and correct as needed.

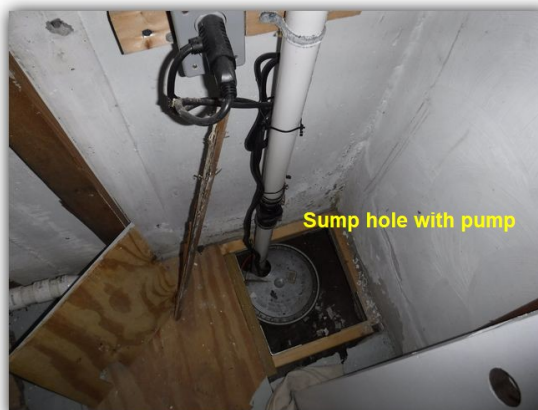
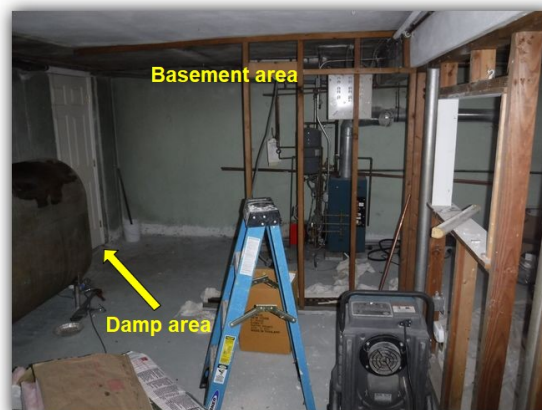
COMPONENT	CONDITION	NOTES / RECOMMENDATIONS	PERSPECTIVE
FOUNDATION			
1 Access:	Marginal	Below items are not evaluated in finished areas.	
2 Foundation walls:	Acceptable	No Action Required	
3 Framing:	Acceptable	No Action Required	
4 Columns/Posts:	Acceptable	No Action Required	
5 Insulation:	Marginal	Insulation is minimal. Add as needed for energy efficiency.	
6 Ventilation:	Acceptable	No Action Required	
7 Sump pump:	Acceptable	No Action Required	
8 Dampness ¹ :	Defective	There are damp areas at time of inspection (by bulkhead and in sump hole). Follow up for history and correct as needed.	
9 Floor/Slab:	Acceptable	No Action Required	
10 Chimney :	Acceptable	No Action Required
